FLOOD CONTROL CHANNELS RESEARCH PROGRAM

CONTRACT REPORT HL-92-1

IDENTIFICATION OF PIPING AND SAPPING EROSION OF STREAMBANKS

D. J. Hagerty

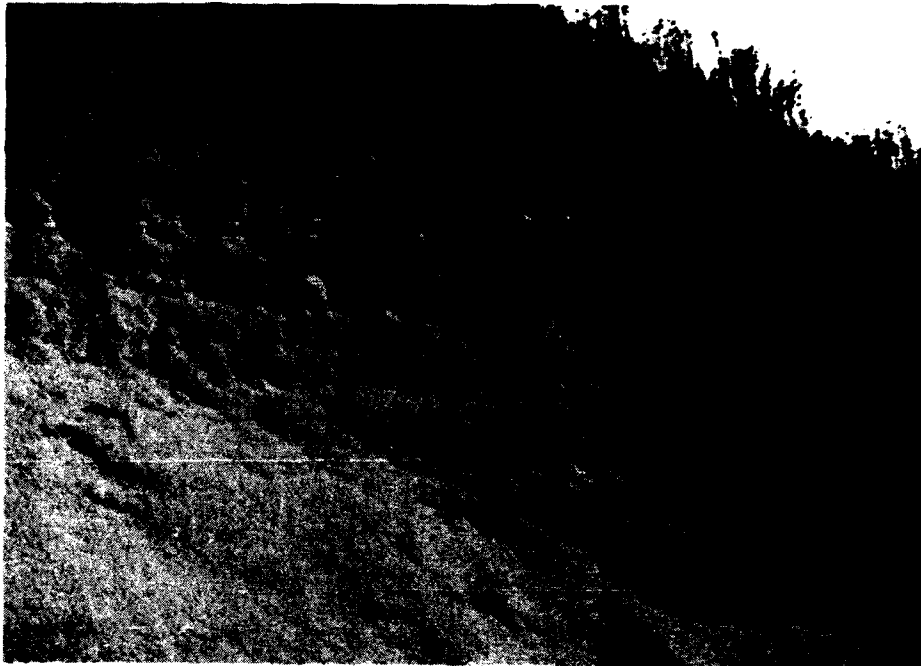
Figure 6. (Sheet 6 of 7)

k. Close view of cavities shown in Figure 6j (Note evidence of sand flow, right side of figure)

l. Close view of cavities shown in Figure 6k (coin is U.S. dime)

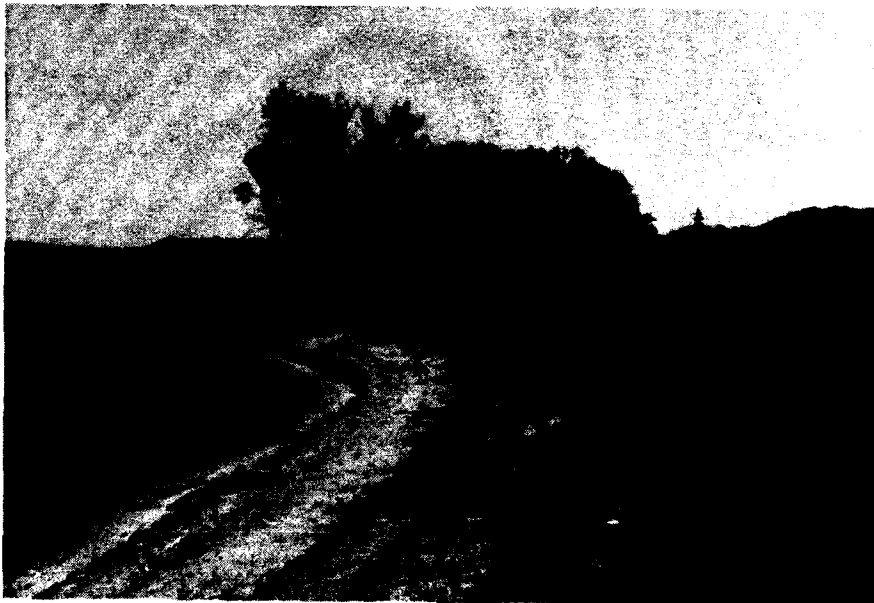
f. Weathered scarps at site shown in Figure 18e

Figure 18. (Sheet 3 of 3)

34. Investigators of bank erosion often conclude that waves have eroded a bank when the bank consists in part of a series of short scarps or nearly vertical faces parallel to the stream, such as the features shown in Figure 18. The features shown in this figure were caused by sapping where water seeped out of thin pervious zones between equally thin less pervious zones. The sandy soils in the pervious sapping zones have been transported out onto the tops of the next lowermost, less pervious layers, and the less pervious layers have formed short, nearly vertical faces as they were undermined by the sapping action. These features can be distinguished from wave-cut benches. Close inspection will show a very irregular alignment of each small scarp; wave-cut benches tend to be very regular in alignment. Viewed from above, each scarp produced by sapping and piping resembles a series of arcs or an irregular line along the length of the bank. Close inspection of the scarps often will reveal reentrant angles at the ends of arcs and other features which could not have been cut by waves striking the bank. These scarps are not conclusive evidence of the operation of piping and sapping activities, because similar features can be created in layers of recently deposited sediments when those layers dewater; the water draining toward the stream from the fresh sediments causes the edges of the sediment layers to be undercut and fail in a mechanism very similar to sapping, but the water does not seep out of the bank proper. Furthermore, these small scarps often are very short-lived, especially if the less pervious layers dry and lose apparent cohesion; the nearly vertical scarps in the drying layers collapse and the final rounded shape of the deteriorated scarp line may be indistinguishable from a similarly dried wave-cut bench line.

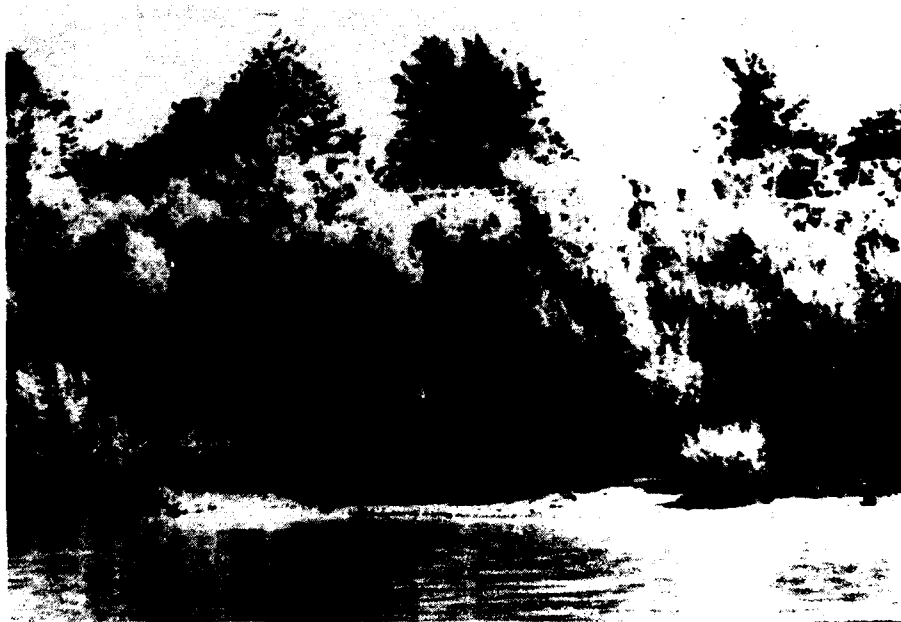
Figure 22. Same site as shown in Figure 21; August, 1986

may mask the evidence of piping activity and make that mechanism very difficult of identify. Similar changes in conditions are shown in Figures 23 and 24. Figure 25 shows bank sites on which piping and sapping had been very active; the feature characteristics of piping/sapping have been obliterated by the operation of other processes.
